# Takane Heights

Shigeru Aoki

Site: Higashi-Nakano, Tokyo  
Structure: reinforced concrete, 4 floors  
Type: Residential building  
Date of construction: 1963  
Date of Renovation: 2009

Ardent attachment for the building is succeeded exceeding the generation. This is a Refinement project of a 46-year-old 4-storied residential building.

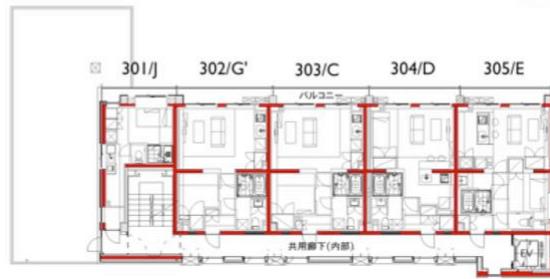
3F PLAN (restored)

The stairs are removed and EV is newly established. Barrier-free for the elderly people. Singles, DINKS, and the students are in the targets. It assumed various residents compared with at first. Proposes the unit plan of 9 types to be suitable for a modern lifestyle.

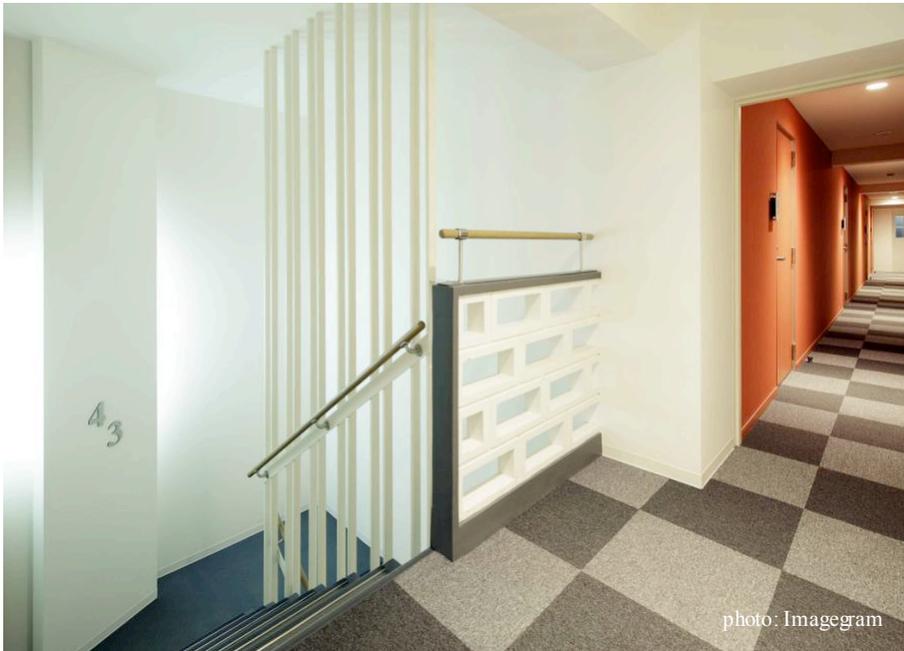
Outdoor shared corridors renovated to indoor corridors. It concentrates MB, PS on the outside wall side for improvement of maintenance and cleaning. Additionally, the unit monopoly area increases, and the profitability also improve. The facade was expressed by these functional layouts. The equipment piping is seen behind the punching metal.
